PROYECTO FINAL DE CARRERA

Patología estructural y del casco:

Métodos de protección, inspección, mantenimiento y reparación

Ingeniería Naval y Oceánica
Junio, 2014

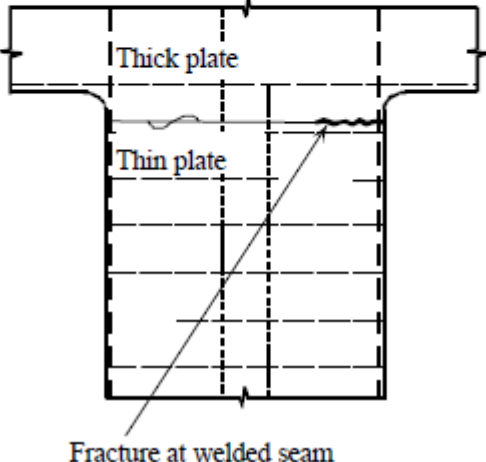
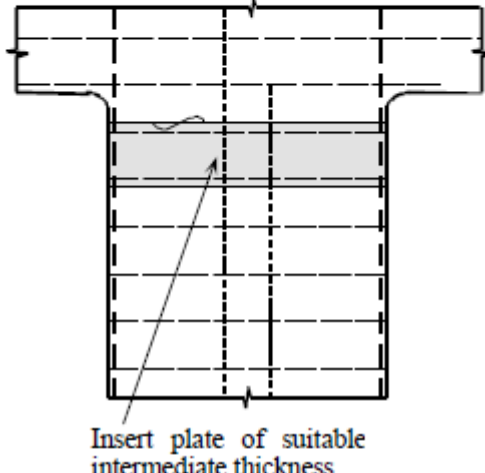
BULK CARRIERS		Guidelines for Surveys, Assessment and Repair of Hull Structure	
Part 1	Cargo hold region	Example No.	
Area 1	Deck structure	2-a	
Detail of damage	Fractures of welded seam between thick plate and thin plate at cross deck		
Sketch of damage		Sketch of repair

Notes on possible cause of damage		Notes on repairs	
<ol style="list-style-type: none">1. Stress concentration created by abrupt change in deck plating thickness.2. In-plane bending in cross deck strip due to torsional (longitudinal) movements of ship sides.3. Welded seam not clear of tangent point of hatch corner.		<ol style="list-style-type: none">1. Insert plate of intermediate thickness is recommended.2. Smooth transition between plates (beveling) should be considered.

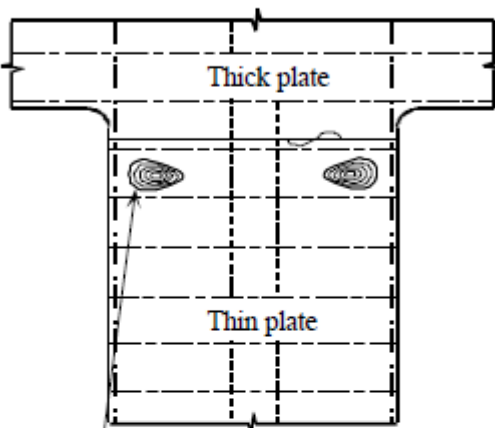
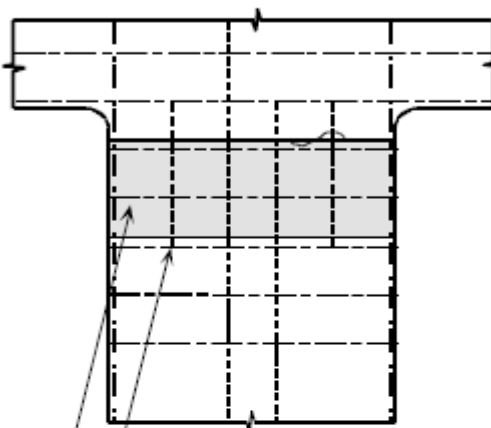
BULK CARRIERS		Guidelines for Surveys, Assessment and Repair of Hull Structure	
Part 1	Cargo hold region	Example No.	
Area 1	Deck structure	2-b	
Detail of damage	Plate buckling in thin plate near thick plate at cross deck		
Sketch of damage		Sketch of repair

<p>Buckling of cross deck plating (Buckling of hatch end structure should be examined. Refer to Example 7-a.)</p>

<p>Additional transverse stiffening and/or insertion of plate with suitable intermediate thickness</p>	
Notes on possible cause of damage		Notes on repairs	
<ol style="list-style-type: none">1. In-plane bending of cross deck strip due to torsional (longitudinal) movement of ship sides, often in combination with corrosion.2. Insufficient plate thickness and/or transverse stiffening.		<ol style="list-style-type: none">1. Transverse stiffeners extending from hatch sides towards centerline at least 10% of breadth of hatch, and/or increased plate thickness in the same area.

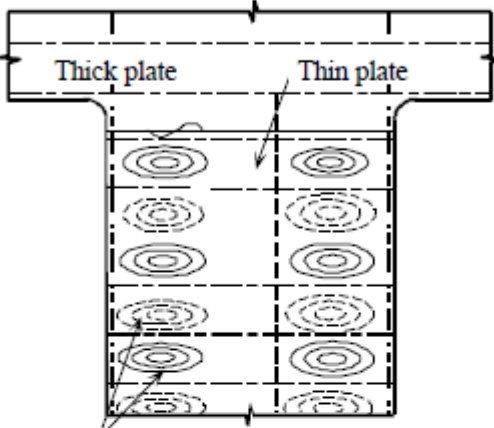
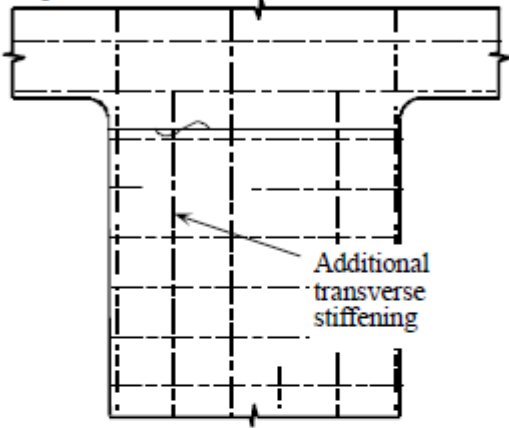
BULK CARRIERS		Guidelines for Surveys, Assessment and Repair of Hull Structure	
Part 1	Cargo hold region		Example No.
Area 1	Deck structure		2-c
Detail of damage		Overall buckling of cross deck plating	
<p>Sketch of damage</p>

<p>Buckling of cross deck plating (Buckling of hatch end structure should be examined. Refer to Example 7-a.)</p>		<p>Sketch of repair</p> <p>Repair A</p>

<p>Additional transverse stiffening</p> <p>Repair B</p>

<p>Insertion of plate with increased thickness</p>	
<p>Notes on possible cause of damage</p> <ol style="list-style-type: none"> 1. Transverse compression of deck due to sea load. 2. Transverse compression of deck due to excessive loading in two adjacent holds. 3. Insufficient plate thickness and/or transverse stiffening. 		<p>Notes on repairs</p> <ol style="list-style-type: none"> 1. Repair A Plating of original thickness in combination with additional transverse stiffening. 2. Repair B Insertion of plating of increased thickness.

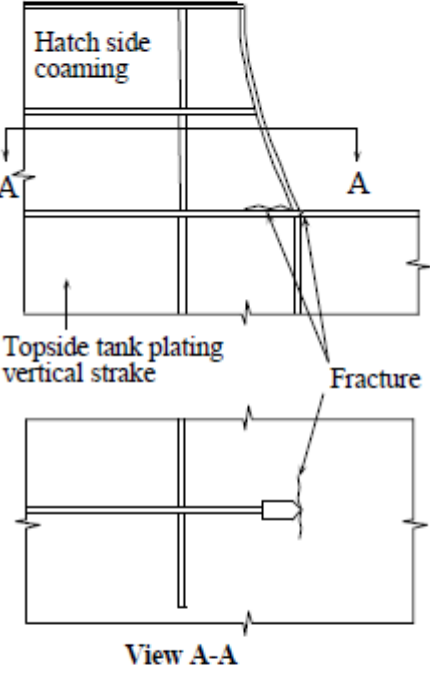
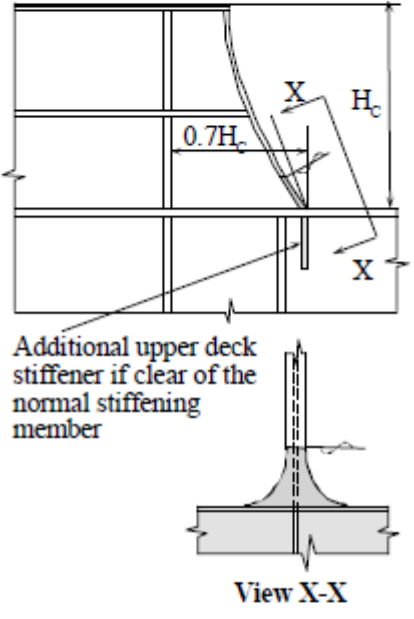
BULK CARRIERS		Guidelines for Surveys, Assessment and Repair of Hull Structure	
Part 1	Cargo hold region	Example No.	
Area 1	Deck structure	3-a	
Detail of damage		Fractures in the web or in the deck at the toes of the longitudinal hatch coaming termination bracket	
Sketch of damage		Sketch of repair

Notes on possible cause of damage		Notes on repairs	
<ol style="list-style-type: none"> 1. This damage is caused by stress concentrations attributed to the design of the bracket. 		<ol style="list-style-type: none"> 1. The design of the bracket can be altered as shown above, however, it is to be ensured that an additional under deck stiffener is provided at the toe of the termination bracket, where the toe is clear of the normal stiffening member. 2. Full penetration weld for a distance of $0.15 H_c$ from toe of side coaming termination bracket and for connection of athwartship gusset bracket to deck. 3. The fracture in deck plating to be veed-out and rewelded or deck plating cropped and part renewed as appropriate, using low hydrogen electrodes for welding.

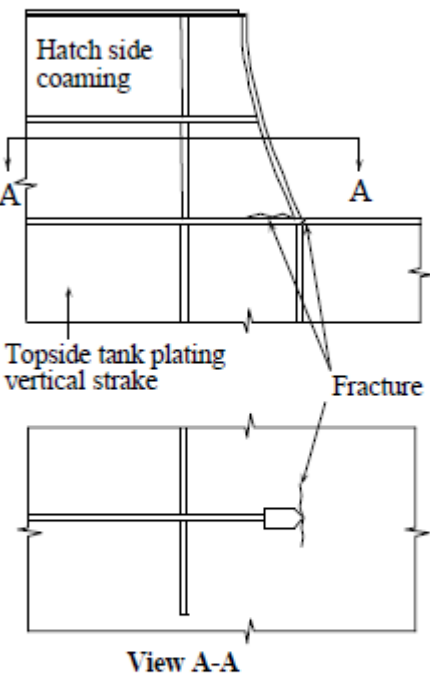
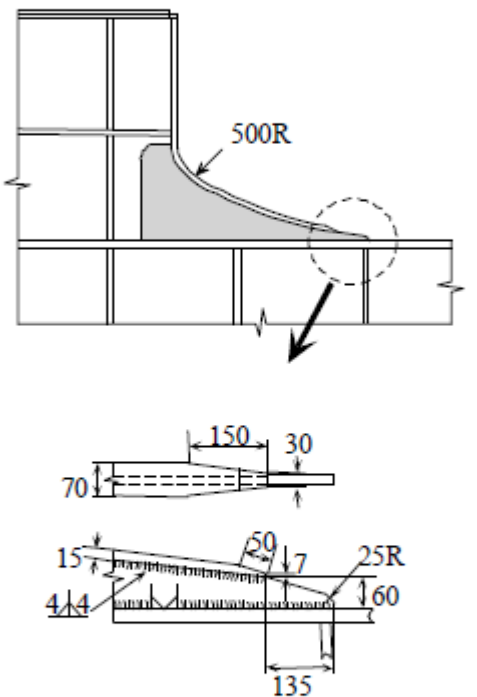
BULK CARRIERS		Guidelines for Surveys, Assessment and Repair of Hull Structure	
Part 1	Cargo hold region		Example No.
Area 1	Deck structure		3-b
Detail of damage		Fractures in the web or in the deck at the toes of the longitudinal hatch coaming termination bracket	
Sketch of damage

Notes on possible cause of damage 1. This damage is caused by stress concentrations attributed to the design of the bracket.		Notes on repairs 1. The design of the bracket can be altered as shown above, however, it is to be ensured that an additional under deck stiffener is provided at the toe of the termination bracket, where the toe is clear of the normal stiffening member. 2. The fracture in deck plating to be vee-out and rewelded or deck plating cropped and part renewed as appropriate, using low hydrogen electrodes for welding.

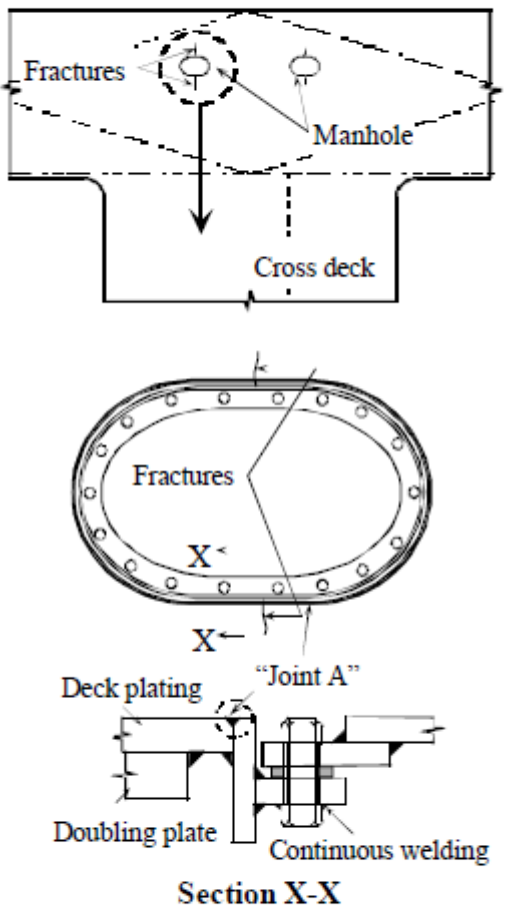
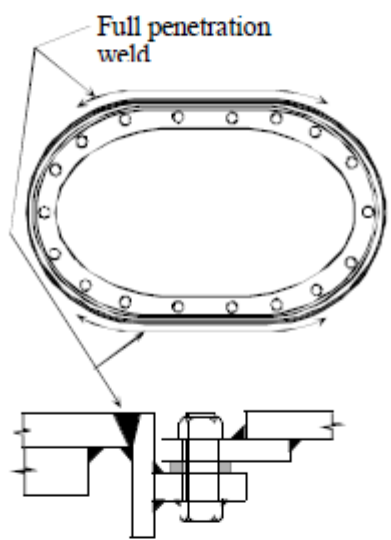
BULK CARRIERS		Guidelines for Surveys, Assessment and Repair of Hull Structure	
Part 1	Cargo hold region	Example No.	
Area 1	Deck structure	4	
Detail of damage		Fractures in deck plating initiated from weld of access manhole	
Sketch of damage		Sketch of repair

<p>Fractures</p> <p>Manhole</p> <p>Cross deck</p> <p>Fractures</p> <p>X</p> <p>X</p> <p>Deck plating</p> <p>Joint A</p> <p>Doubling plate</p> <p>Continuous welding</p> <p>Section X-X</p>

<p>Full penetration weld</p>	
Notes on possible cause of damage <ol style="list-style-type: none"> 1. Heavy weather. 2. Improper welding of joint "A". 		Notes on repairs <ol style="list-style-type: none"> 1. The fracture in deck plating to be veed-out and rewelded, or deck plating cropped and part renewed if considered necessary. 2. Full penetration of joint "A" should be considered.

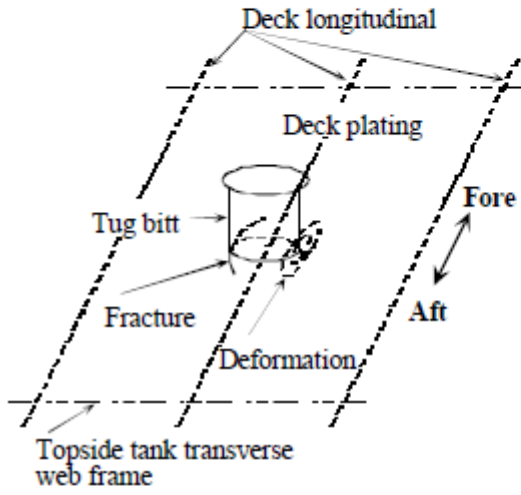
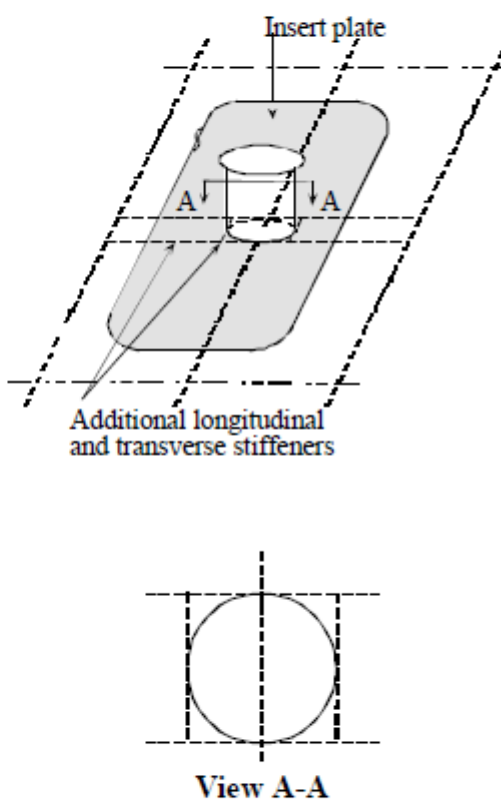
BULK CARRIERS		Guidelines for Surveys, Assessment and Repair of Hull Structure	
Part 1	Cargo hold region	Example No.	
Area 1	Deck structure	5	
Detail of damage		Deformed and fractured deck plating around tug bitt	
Sketch of damage		Sketch of repair

Notes on possible cause of damage 1. Insufficient strength		Notes on repairs 1. Fractured/deformed deck plating should be cropped and part renewed. 2. Reinforcement by stiffeners should be considered.

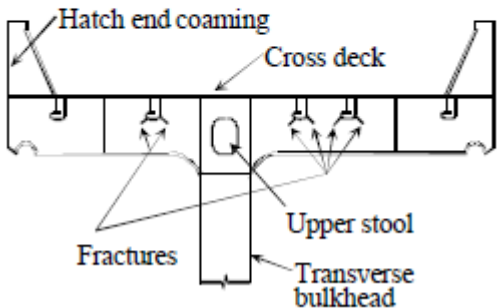
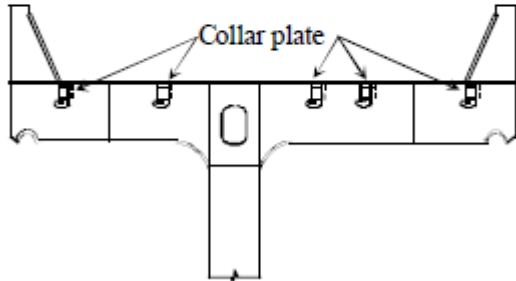
BULK CARRIERS		Guidelines for Surveys, Assessment and Repair of Hull Structure	
Part 1	Cargo hold region		Example No.
Area 1	Deck structure		6
Detail of damage	Fractures around cut-outs in cross deck girder		
Sketch of damage

Notes on possible cause of damage 1. Stress concentration at the cut-outs in cross deck girder.		Notes on repairs 1. Fractured web plate of cross deck girder to be cropped and part renewed. 2. Collar plates to be provided.

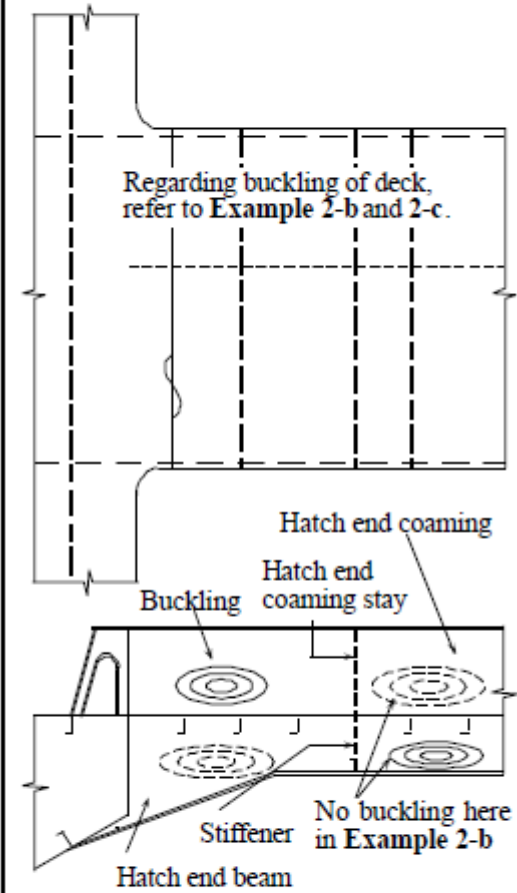
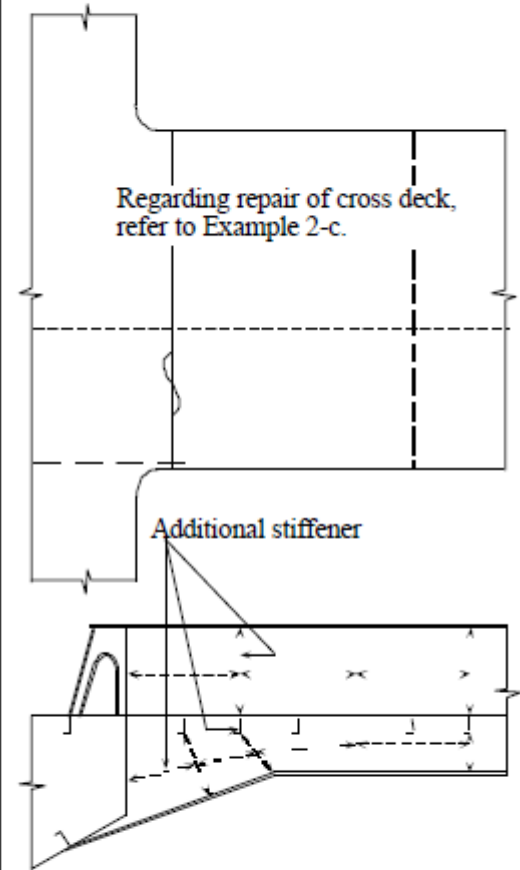
BULK CARRIERS		Guidelines for Surveys, Assessment and Repair of Hull Structure	
Part 1	Cargo hold region		Example No.
Area 1	Deck structure		7-a
Detail of damage		Buckling of hatch coaming and hatch end beam	
Sketch of damage		Sketch of repair

<p>Regarding buckling of deck, refer to Example 2-b and 2-c.</p> <p>Hatch end coaming</p> <p>Buckling</p> <p>Hatch end coaming stay</p> <p>Stiffener</p> <p>Hatch end beam</p> <p>No buckling here in Example 2-b</p>

<p>Regarding repair of cross deck, refer to Example 2-c.</p> <p>Additional stiffener</p>	
Notes on possible cause of damage <ol style="list-style-type: none"> 1. Additional transverse forces due to heavy seas, and torsional loading. 2. Inadvertent overloading of cargo spaces. 		Notes on repairs <ol style="list-style-type: none"> 1. If buckling is due to loss in strength induced by corrosion, the buckled zone to be cropped and renewed as necessary. 2. If buckling results from inadequate strength, stiffeners should be fitted in addition to cropping and renewal of buckled zone.

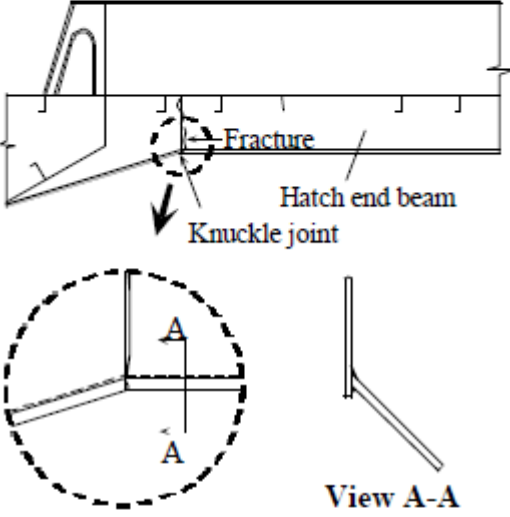
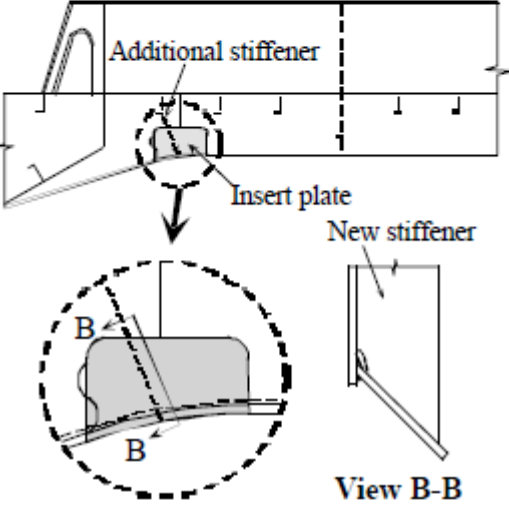
BULK CARRIERS		Guidelines for Surveys, Assessment and Repair of Hull Structure	
Part 1	Cargo hold region	Example No.	
Area 1	Deck structure	7-b	
Detail of damage		Fractures in hatch end beam at knuckle joint	
Sketch of damage		Sketch of repair

Notes on possible cause of damage		Notes on repairs	
<ol style="list-style-type: none"> 1. Stress concentration at knuckle joint. 		<ol style="list-style-type: none"> 1. Fractured part to be cropped and renewed. 2. Improvement to avoid stress concentration at knuckle joint should be considered.

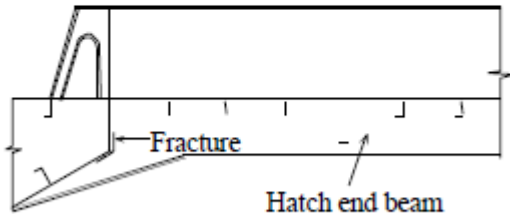
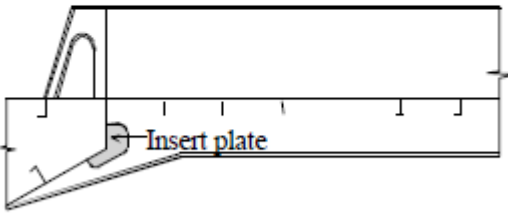
BULK CARRIERS		Guidelines for Surveys, Assessment and Repair of Hull Structure	
Part 1	Cargo hold region	Example No.	
Area 1	Deck structure	8	
Detail of damage		Fractures in hatch end beam at the joint to topside tank	
Sketch of damage		Sketch of repair

Notes on possible cause of damage		Notes on repairs	
<ol style="list-style-type: none">1. Misalignment of the hatch end beam with transverse web frame in topside tank.2. Stress concentration.		<ol style="list-style-type: none">1. Fractured part to be cropped and renewed.

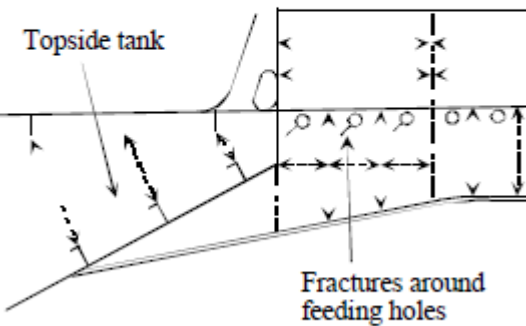
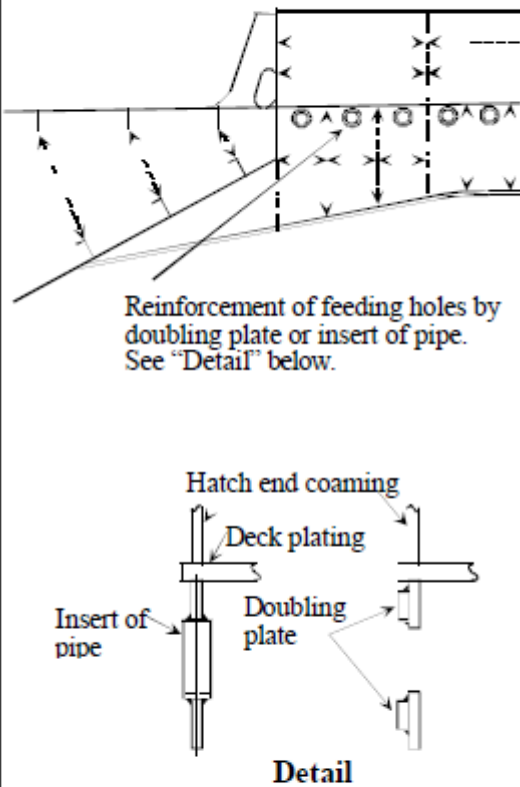
BULK CARRIERS		Guidelines for Surveys, Assessment and Repair of Hull Structure	
Part 1	Cargo hold region		Example No.
Area 1	Deck structure		9
Detail of damage		Fractures in hatch end beam around feeding holes	
Sketch of damage		Sketch of repair

<p>Topside tank</p> <p>Fractures around feeding holes</p>

<p>Reinforcement of feeding holes by doubling plate or insert of pipe. See "Detail" below.</p> <p>Hatch end coaming</p> <p>Deck plating</p> <p>Insert of pipe</p> <p>Doubling plate</p> <p>Detail</p>	
Notes on possible cause of damage		Notes on repairs	
<ol style="list-style-type: none"> 1. Inadequate reinforcement around feeding hole. 2. Corrosion. 		<ol style="list-style-type: none"> 1. Fractured part to be veed-out or cropped and renewed. 2. If the fractured part is free from corrosion, reinforcement should be considered.

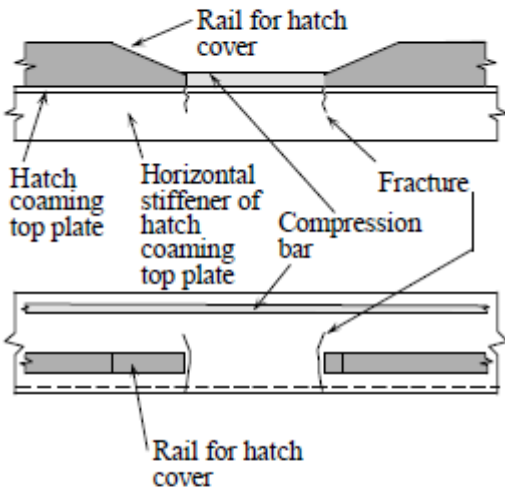
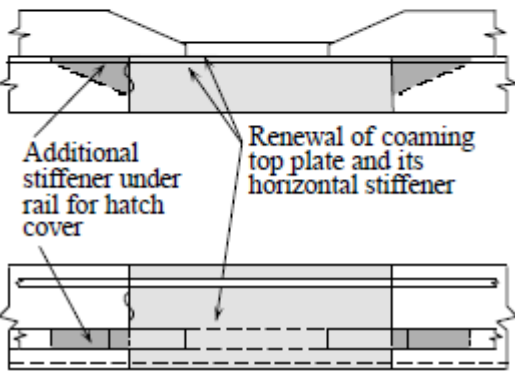
BULK CARRIERS		Guidelines for Surveys, Assessment and Repair of Hull Structure	
Part 1	Cargo hold region		Example No.
Area 1	Deck structure		10-a
Detail of damage		Fractures in hatch coaming top plate at the termination of rail for hatch cover	
Sketch of damage		Sketch of repair

Notes on possible cause of damage		Notes on repairs	
<ol style="list-style-type: none"> 1. Stress concentration at the termination of the rail for hatch cover due to poor design. 		<ol style="list-style-type: none"> 1. Fractured plate is to be cropped and part renewed. 2. Thicker insert plate and/or reinforcement by additional stiffener under the top plate should be considered. Also refer to Example 10-b.

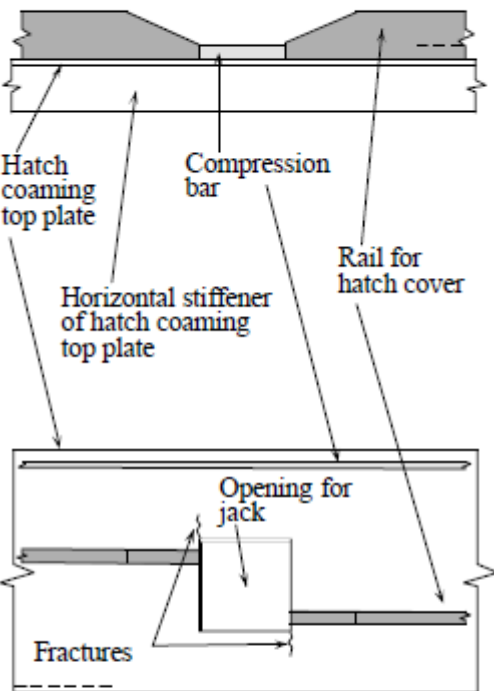
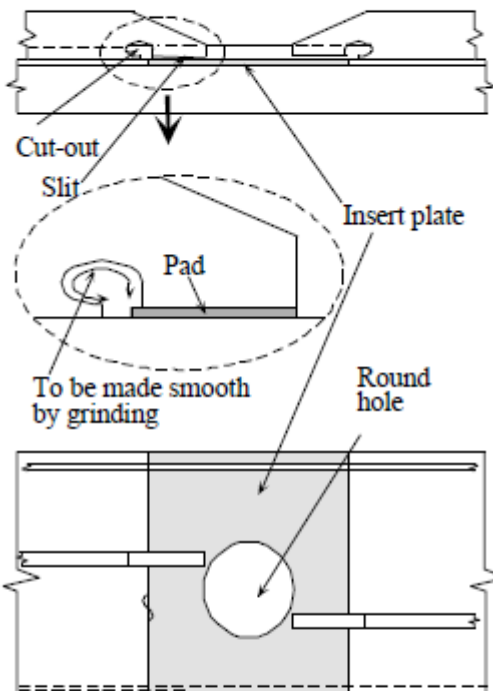
BULK CARRIERS		Guidelines for Surveys, Assessment and Repair of Hull Structure	
Part 1	Cargo hold region	Example No.	
Area 1	Deck structure	10-b	
Detail of damage		Fractures in hatch coaming top plate at the termination of rail for hatch cover	
Sketch of damage

Notes on possible cause of damage 1. Stress concentration at the termination of the rail for hatch cover due to poor design of opening.		Notes on repairs 1. Fractured plate is to be cropped and part renewed. 2. Thicker insert plate and/or reduction of stress concentration adopting large radius should be considered. Or cut-out in the rail and detachment of the welds as shown in the above drawing should be considered in order to reduce the stress of the corner of the opening.

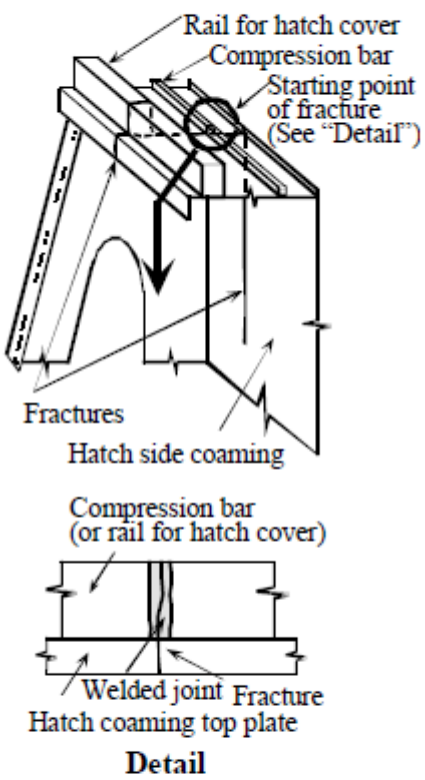
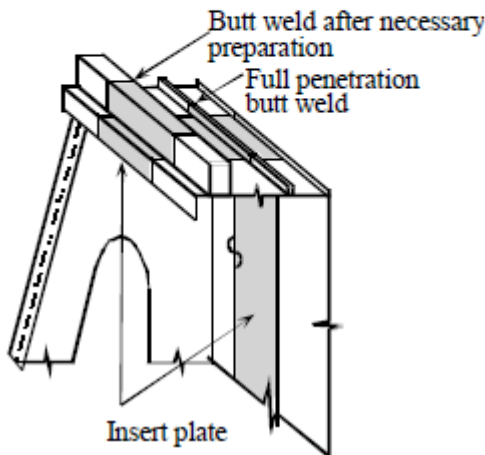
BULK CARRIERS		Guidelines for Surveys, Assessment and Repair of Hull Structure	
Part 1	Cargo hold region		Example No.
Area 1	Deck structure		11
Detail of damage		Fractures in hatch coaming top plate initiated from butt weld of compression bar	
<p>Sketch of damage</p>

<p>Notes on possible cause of damage</p> <ol style="list-style-type: none"> 1. Heavy weather 2. Insufficient preparation of weld of compression bar and/or rail (Although the compression bar and rail are not longitudinal strength members, they subject same longitudinal stress as longitudinal members) 3. Crack may initiate from insufficient penetration of weld of rail for hatch cover. 		<p>Notes on repairs</p> <ol style="list-style-type: none"> 1. Loading condition of the ship and proper welding procedure should be carefully considered. 2. Fractured structure is to be cropped and renewed if considered necessary. (Small fracture may be veed-out and rewelded.) 3. Full penetration welding should be applied to the butt weld of compression bar and rail.

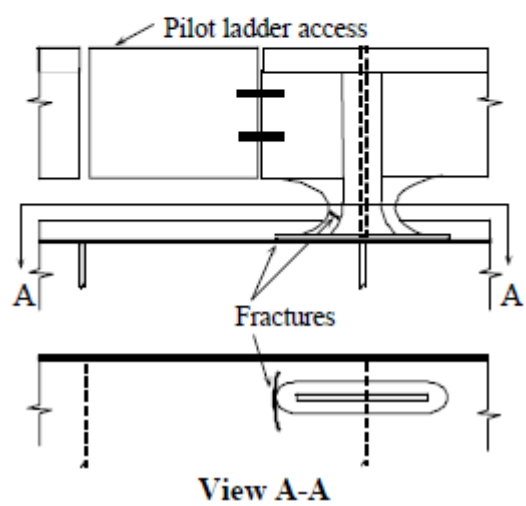
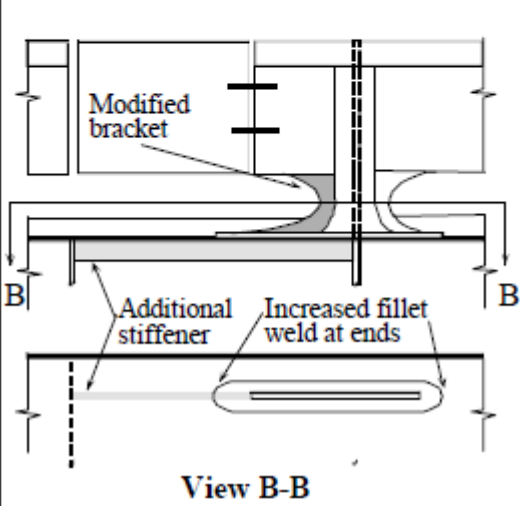
BULK CARRIERS		Guidelines for Surveys, Assessment and Repair of Hull Structure	
Part 1	Cargo hold region	Example No.	
Area 1	Deck structure	12	
Detail of damage		Fractures in deck plating at the pilot ladder access of bulwarks	
Sketch of damage		Sketch of repair

Notes on possible cause of damage 1. Stress concentration at the termination of bulwarks.		Notes on repairs 1. Fractured deck plating should be cropped and part renewed. 2. Reduction of stress concentration should be considered. In the above figure gusset plate was replaced with soft type for the fracture in gusset plate and pad plate was increased. Additional stiffeners were provided for the fracture in deck plating.

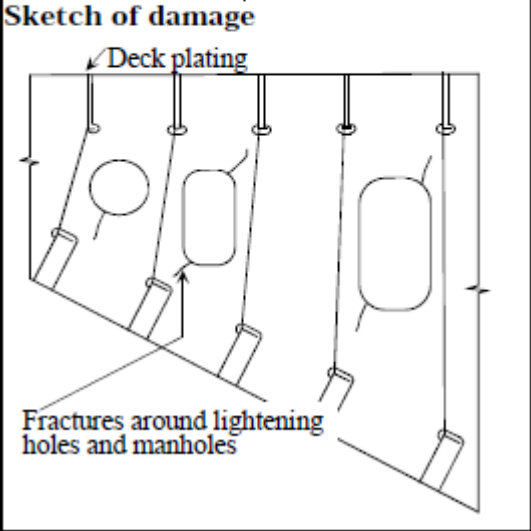
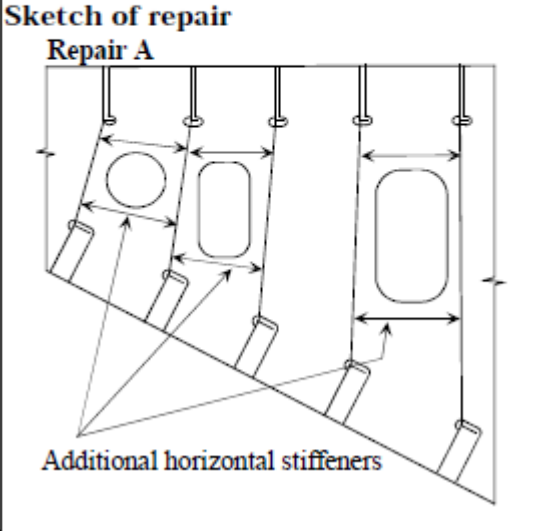
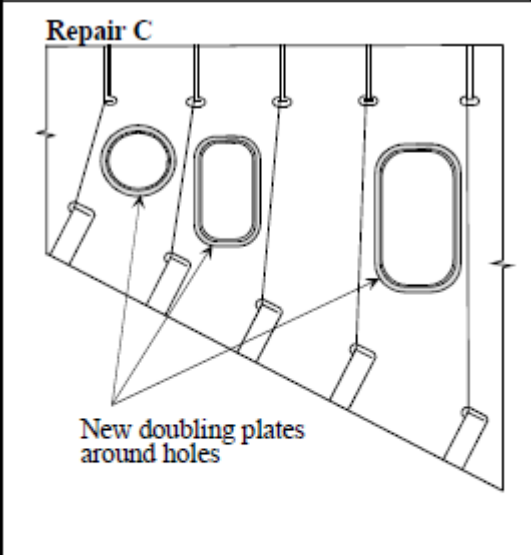
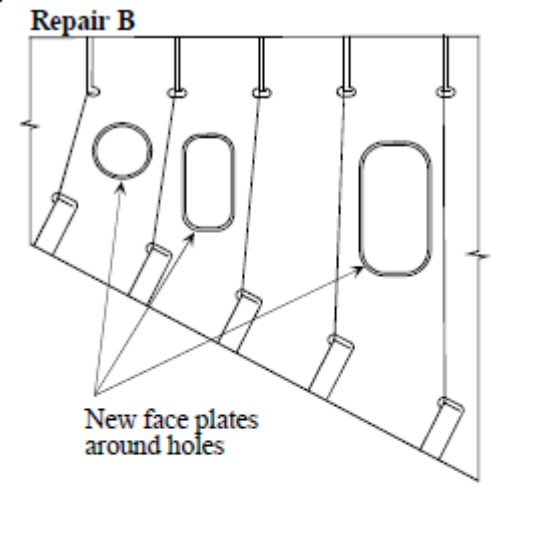
BULK CARRIERS		Guidelines for Surveys, Assessment and Repair of Hull Structure
Part 1	Cargo hold region	Example No.
Area 2	Topside tank structure	1
Detail of damage	Fractures around unstiffened lightening holes and manholes in wash bulkhead	
Sketch of damage		Sketch of repair

Notes on possible cause of damage 1. General levels of corrosion and presence of stress concentration.		Notes on repairs 1. Corroded/fractured plate should be cropped and renewed with plating of enhanced thickness. 2. Reinforcement should be considered.

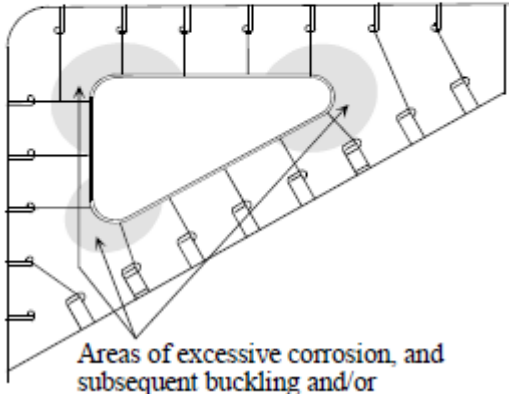
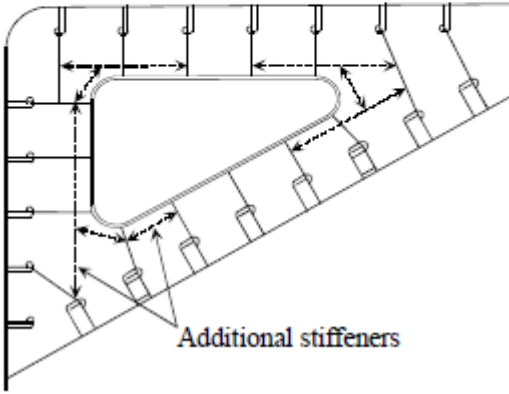
BULK CARRIERS		Guidelines for Surveys, Assessment and Repair of Hull Structure
Part 1	Cargo hold region	Example No.
Area 2	Topside tank structure	2-a
Detail of damage	Thinning and subsequent buckling of web plating in the vicinity of the radii of the opening	
Sketch of damage		Sketch of repair

<p>Areas of excessive corrosion, and subsequent buckling and/or</p>

<p>Additional stiffeners</p>
Notes on possible cause of damage		Notes on repairs
<ol style="list-style-type: none"> 1. Insufficient buckling strength. 2. Corrosion due to stress concentration at corners. 		<ol style="list-style-type: none"> 1. Buckled plating is to be cropped and parts renewed, if necessary. 2. Additional stiffeners as shown above and/or renewal with plating of increased thickness should be considered.

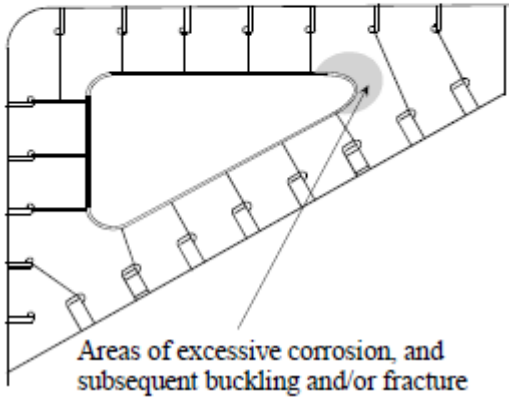
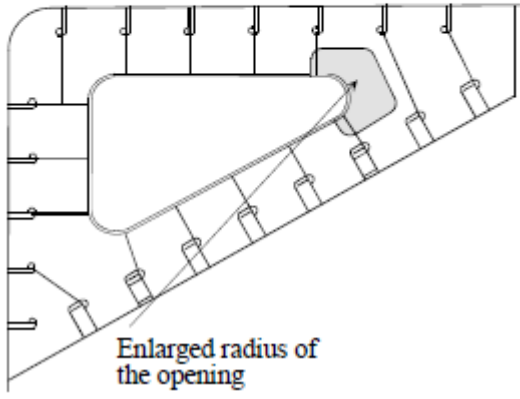
BULK CARRIERS		Guidelines for Surveys, Assessment and Repair of Hull Structure	
Part 1	Cargo hold region	Example No.	
Area 2	Topside tank structure	2-b	
Detail of damage		Thinning and subsequent buckling of web plating in the vicinity of the radii of the opening	
Sketch of damage		Sketch of repair

<p>Areas of excessive corrosion, and subsequent buckling and/or fracture</p>

<p>Enlarged radius of the opening</p>	
Notes on possible cause of damage		Notes on repairs	
<ol style="list-style-type: none"> Corrosion caused by stress concentration at the corner due to insufficient radius for the opening. 		<ol style="list-style-type: none"> Corroded/buckled plating is to be cropped and parts renewed with plating of increased thickness and additional stiffeners are preferable to minimize deflection. An attempt should be made to improve the design of the radius if felt necessary.

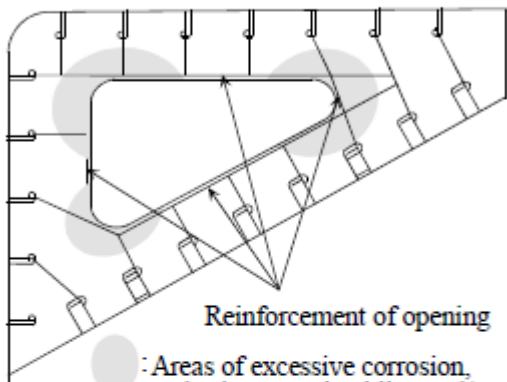
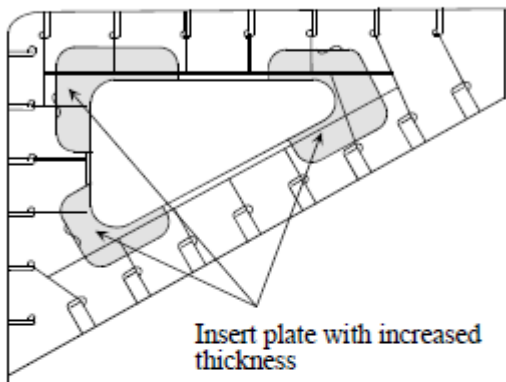
BULK CARRIERS		Guidelines for Surveys, Assessment and Repair of Hull Structure	
Part 1	Cargo hold region	Example No.	
Area 2	Topside tank structure	2-c	
Detail of damage	Thinning and subsequent buckling of web plating in the vicinity of the radii of the opening		
Sketch of damage		Sketch of repair

<p>Reinforcement of opening</p> <p>Areas of excessive corrosion, and subsequent buckling and/or</p>

<p>Insert plate with increased thickness</p>	
Notes on possible cause of damage		Notes on repairs	
1. Additional stresses at the free edge of transverse web. (In Example 2-a - 2-c face plate is provided for the reinforcement of the opening.)		1. Corroded/buckled plating is to be cropped and part renewed with plating of increased thickness.

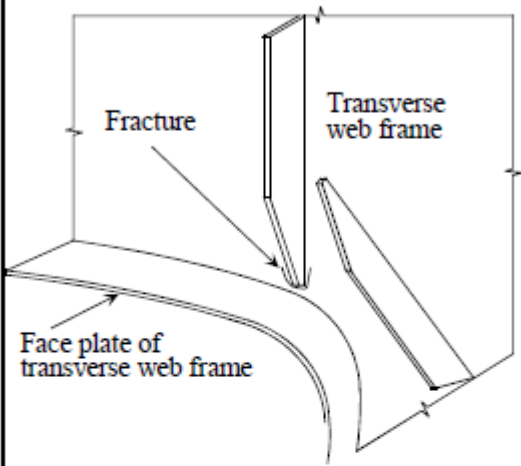
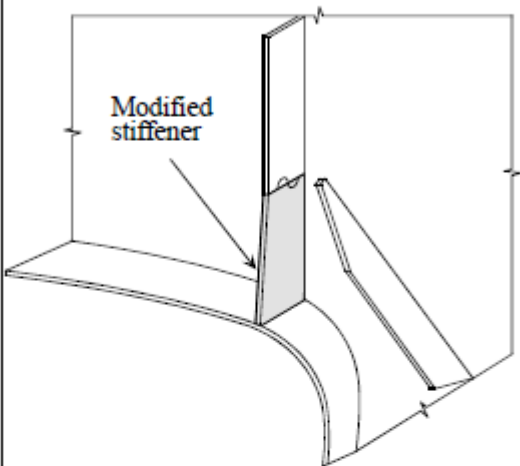
BULK CARRIERS		Guidelines for Surveys, Assessment and Repair of Hull Structure	
Part 1	Cargo hold region	Example No.	
Area 2	Topside tank structure	3	
Detail of damage		Fractures in transverse web at sniped end of stiffener	
Sketch of damage		Sketch of repair

Notes on possible cause of damage		Notes on repairs	
1. Stress concentration.		1. Fracture can be veed-out and welded provided the plating is not generally corroded. If necessary, fractured plating should be cropped and renewed. 2. Excessive stress concentration at the end of stiffener should be avoided.

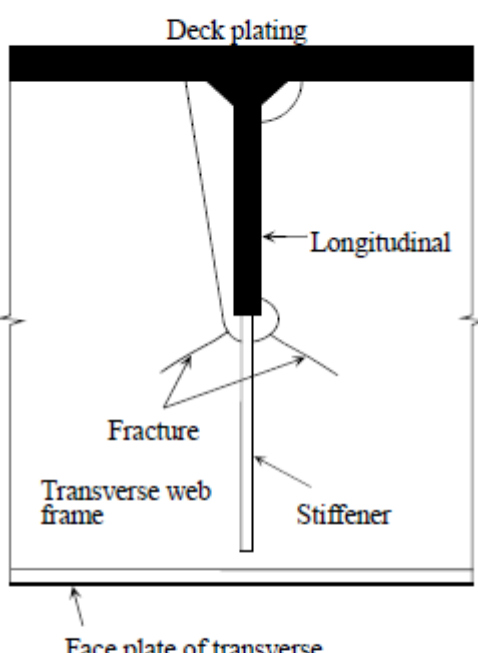
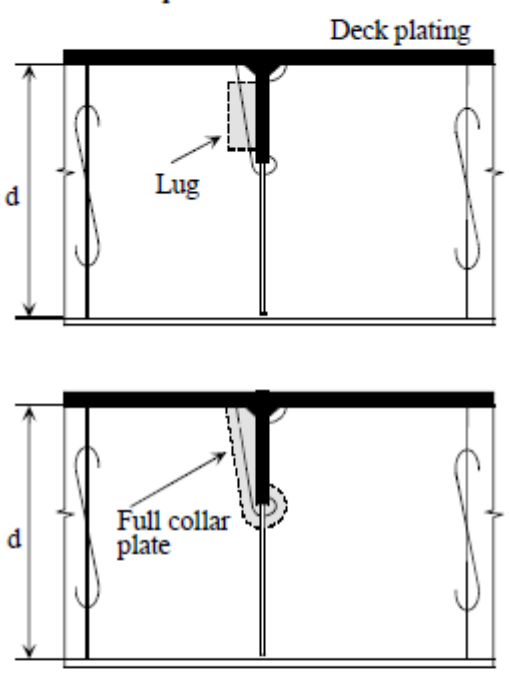
BULK CARRIERS		Guidelines for Surveys, Assessment and Repair of Hull Structure	
Part 1	Cargo hold region	Example No.	
Area 2	Topside tank structure	4-a	
Detail of damage		Fractures at slots in way of transverse web frame	
Sketch of damage		Sketch of repair

<p>(Note) Full collar plate where the depth of cut-out is more than 0.4 times the depth of web frame ($0.4d$) and in an areas of high shear stress</p>	
Notes on possible cause of damage		Notes on repairs	
<ol style="list-style-type: none">1. Damage may be created by local shear stress concentrations due to large cut-outs for notch.2. Also deficient welds (fillet welds between deck longitudinal and stiffener).		<ol style="list-style-type: none">1. Crop and part renew the web plating.2. Close the cut-out by introducing a lug or alternatively fit a full collar plate.

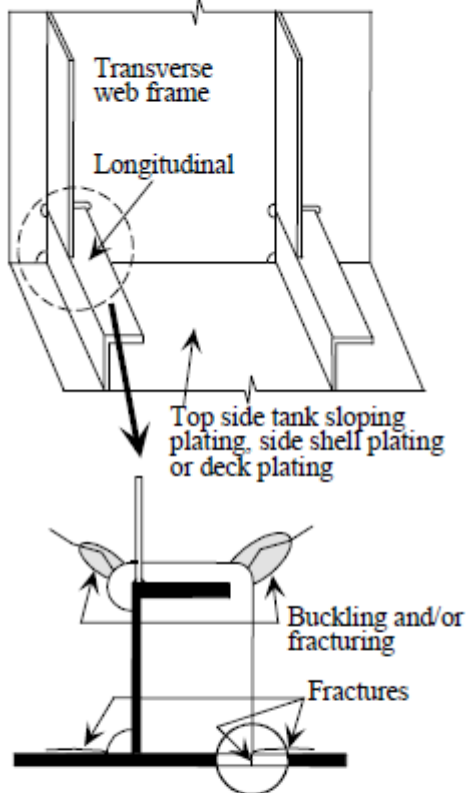
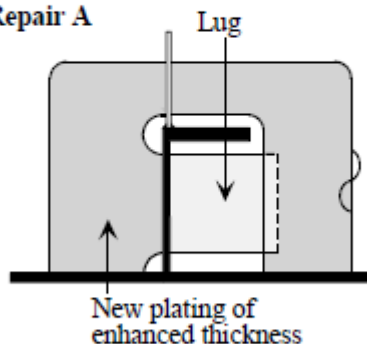
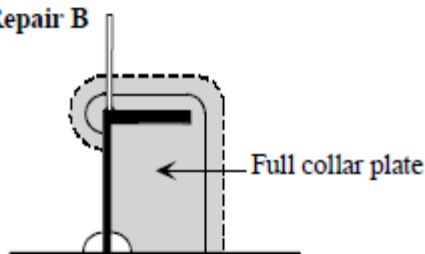
BULK CARRIERS		Guidelines for Surveys, Assessment and Repair of Hull Structure
Part 1	Cargo hold region	Example No.
Area 2	Topside tank structure	4-b
Detail of damage Fractures and buckling at slots in way of transverse web frame		
Sketch of damage		Sketch of repair

<p>Transverse web frame</p> <p>Longitudinal</p> <p>Top side tank sloping plating, side shell plating or deck plating</p> <p>Buckling and/or fracturing</p> <p>Fractures</p>		<p>Repair A</p>

<p>Lug</p> <p>New plating of enhanced thickness</p> <p>Repair B</p>

<p>Full collar plate</p>
Notes on possible cause of damage		Notes on repairs
<p>1. Damage can be caused by general levels of corrosion and presence of stress concentration associated with the presence of a cut-out.</p>		<p>1. If fractures are significant then crop and part renew the plating otherwise the fracture can be veed-out and welded provided the plating is not generally corroded.</p> <p>2. Repair A Lug should be considered.</p> <p>3. Repair B Full collar plate should be considered where the depth of cut-out is more than 0.4 times the depth of web frame and in an area of high shear stress or the existing lug proves to be ineffective.</p>

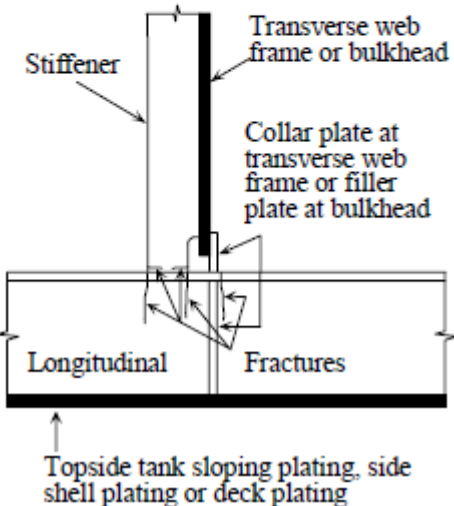
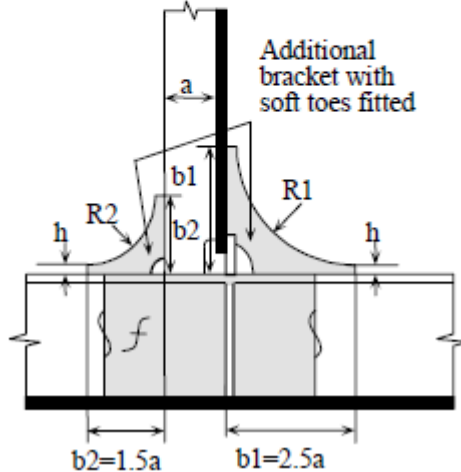
BULK CARRIERS		Guidelines for Surveys, Assessment and Repair of Hull Structure
Part 1	Cargo hold region	Example No.
Area 2	Topside tank structure	5
Detail of damage	Fractures in longitudinal at transverse web frame or bulkhead	
Sketch of damage		Sketch of repair

<p>f: Where required, the longitudinal to be cropped and part renewed</p> <ol style="list-style-type: none"> 1. For a slope at toes max. 1:3, $R1=(b1-h) \times 1.6$ and $R2=(b2-h) \times 1.6$ 2. Soft toe bracket to be welded first to longitudinal 3. Scallop in bracket to be as small as possible, recommended max. 35mm 4. If toes of brackets are ground smooth, full penetration welds in way to be provided 5. Maximum length to thickness ratio =50:1 for unstiffened bracket edge 6. Toe height, h, to be as small as possible (10-15mm)
Notes on possible cause of damage		Notes on repairs
<ol style="list-style-type: none"> 1. Damage can be caused by stress concentrations leading to accelerated fatigue in this region. 		<ol style="list-style-type: none"> 1. If fracture extends to over one third of the depth of the longitudinal, then crop and part renew. Otherwise the fracture can be veed-out and welded.

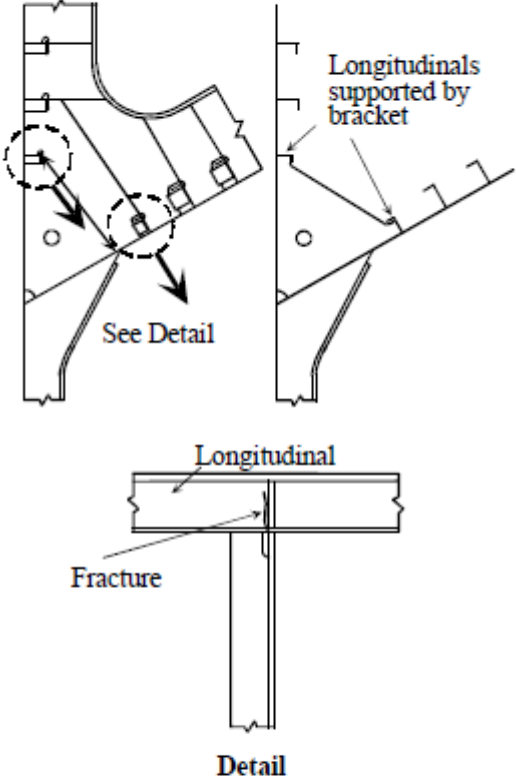
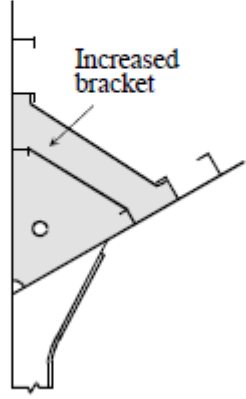
BULK CARRIERS		Guidelines for Surveys, Assessment and Repair of Hull Structure
Part 1	Cargo hold region	Example No.
Area 2	Topside tank structure	6
Detail of damage		Fractures in the lowest longitudinal at transverse web frame
Sketch of damage

<p>Longitudinals supported by bracket</p> <p>See Detail</p> <p>Longitudinal</p> <p>Fracture</p> <p>Detail</p>

<p>Increased bracket</p>
Notes on possible cause of damage		Notes on repairs
<p>1. Insufficient scantling for torsional rigidity (The lowest longitudinal is usually supported by bracket(s) as shown in the above and smaller scantling may be adopted. However, the lowest longitudinal undergoes torsion from side shell frame through bracket(s) and may suffer fracture.)</p>		<p>1. Fractured part to be cropped and renewed.</p> <p>2. Size of bracket should be increased</p>

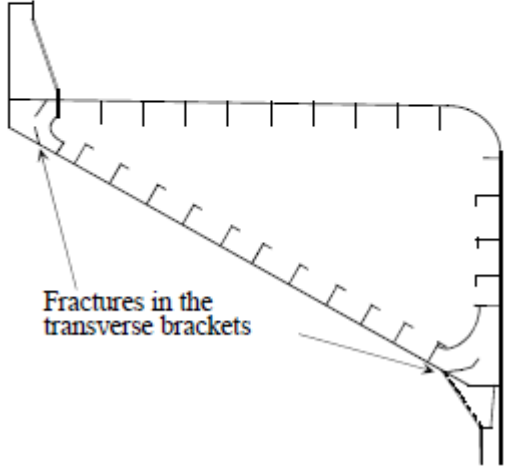
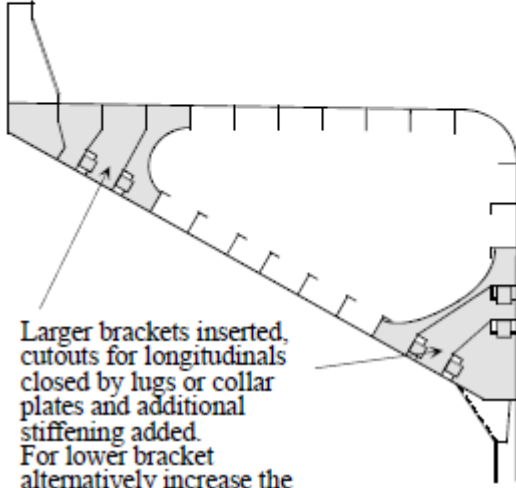
BULK CARRIERS		Guidelines for Surveys, Assessment and Repair of Hull Structure	
Part 1	Cargo hold region	Example No.	
Area 2	Topside tank structure	7-a	
Detail of damage		Fractures in transverse brackets	
Sketch of damage		Sketch of repair

<p>Fractures in the transverse brackets</p>

<p>Larger brackets inserted, cutouts for longitudinals closed by lugs or collar plates and additional stiffening added. For lower bracket alternatively increase the thickness</p>	
Notes on possible cause of damage		Notes on repairs	
<ol style="list-style-type: none"> 1. General levels of corrosion and presence of stress concentrations. 2. Misalignment of the brackets with adjoining structure, e.g. side shell frame brackets and/or coaming brackets. 3. High shear stresses due to insufficient bracket size. 4. Inadvertent overloading. 		<ol style="list-style-type: none"> 1. If the damage is caused by misalignment with the side shell frame brackets or the hatch coaming brackets the misalignment is to be rectified and the replacement by larger brackets incorporated only if considered necessary.

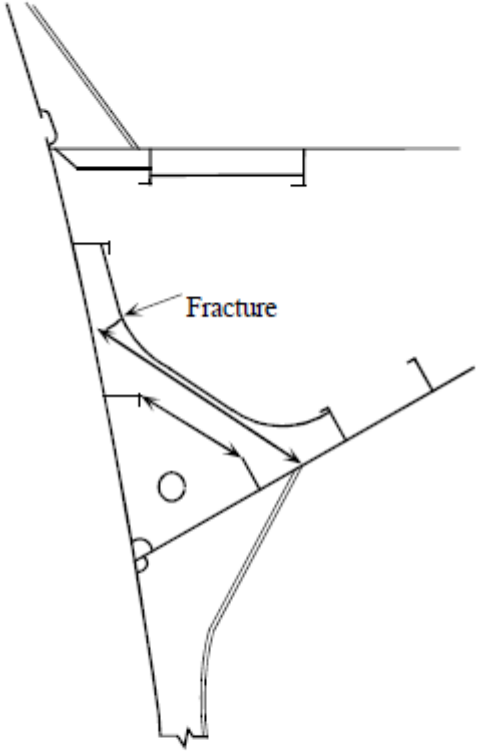
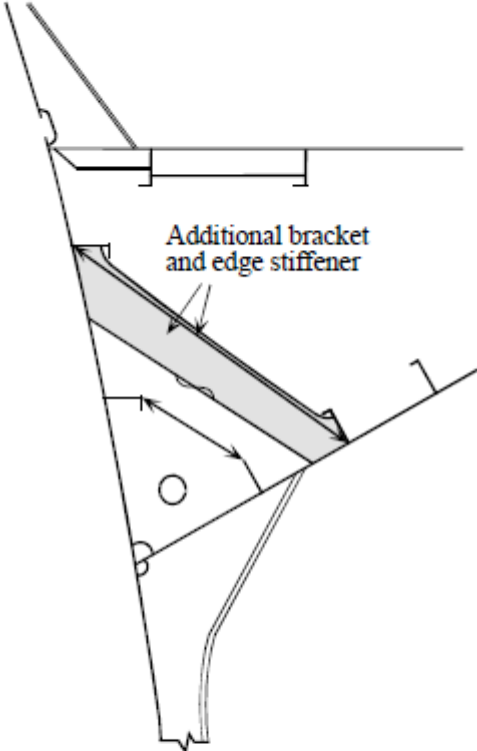
BULK CARRIERS		Guidelines for Surveys, Assessment and Repair of Hull Structure	
Part 1	Cargo hold region	Example No.	
Area 2	Topside tank structure	7-b	
Detail of damage		Fractures in transverse bracket	
Sketch of damage		Sketch of repair

Notes on possible cause of damage		Notes on repairs	
<ol style="list-style-type: none"> 1. Insufficient strength. 2. Corrosion. 		<ol style="list-style-type: none"> 1. Fractured part to be cropped and renewed. 2. If the fractured part is free from corrosion, increased size and thickness should be considered. Partial renewal of the bracket may be accepted depending on the nature of the fracture.

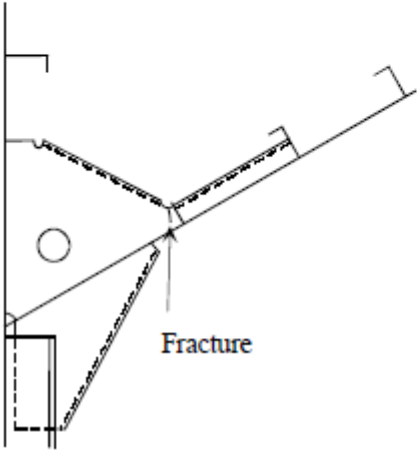
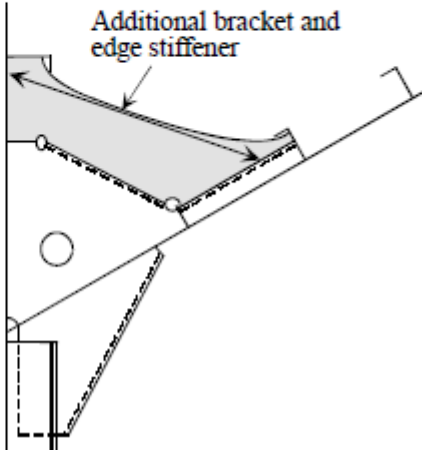
BULK CARRIERS		Guidelines for Surveys, Assessment and Repair of Hull Structure
Part 1	Cargo hold region	Example No.
Area 2	Topside tank structure	7-c
Detail of damage	Fractures at toes of transverse bracket	
Sketch of damage		Sketch of repair

Notes on possible cause of damage		Notes on repairs
1. Stress concentration due to the shape of the bracket.		1. Cracked weld to be veed-out and rewelded.

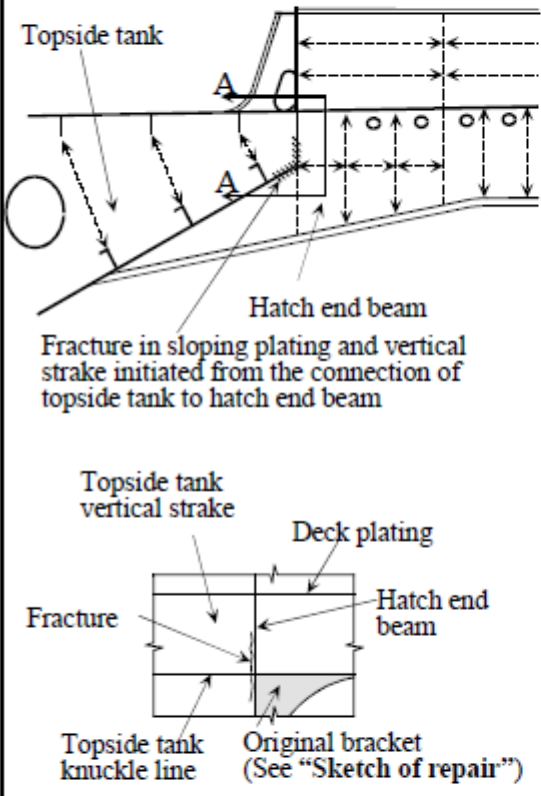
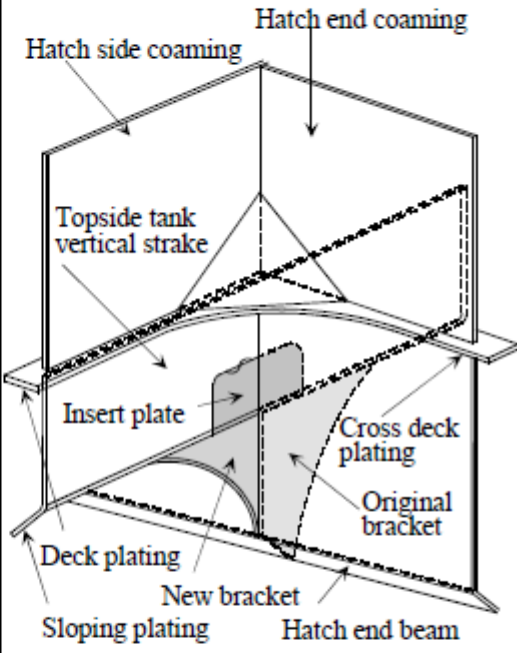
<p>Topside tank</p> <p>Hatch end beam</p> <p>Fracture in sloping plating and vertical strake initiated from the connection of topside tank to hatch end beam</p> <p>Topside tank vertical strake</p> <p>Deck plating</p> <p>Fracture</p> <p>Hatch end beam</p> <p>Topside tank knuckle line</p> <p>Original bracket (See "Sketch of repair")</p> <p>View A-A</p>

<p>Hatch side coaming</p> <p>Hatch end coaming</p> <p>Topside tank vertical strake</p> <p>Insert plate</p> <p>Cross deck plating</p> <p>Original bracket</p> <p>Deck plating</p> <p>New bracket</p> <p>Sloping plating</p> <p>Hatch end beam</p>

Notes on possible cause of damage		Notes on repairs
<ol style="list-style-type: none"> 1. Stress concentration at the connection of hatch end beam to topside tank. 		<ol style="list-style-type: none"> 1. Fractured part to be cropped and renewed with increased thickness. 2. Additional bracket should be considered for reinforcement.
